MEMORANDUM

SUBJECT: Public hearing and consideration of an application to designate the property at 1919 14th St. as a local historic landmark as per Section 9-11-5 of the Boulder Revised Code, 1981 (HIS2014-00186).

The Landmarks Board recommends to the City Council that it designate the property at 1919 14th St. as a local historic landmark, to be known as the **Colorado Building**, finding that it meets the standards for individual landmark designation in Sections 9-11-1 and 9-11-2, B.R.C. 1981, and adopts the staff memorandum, including the following as the findings of the board:

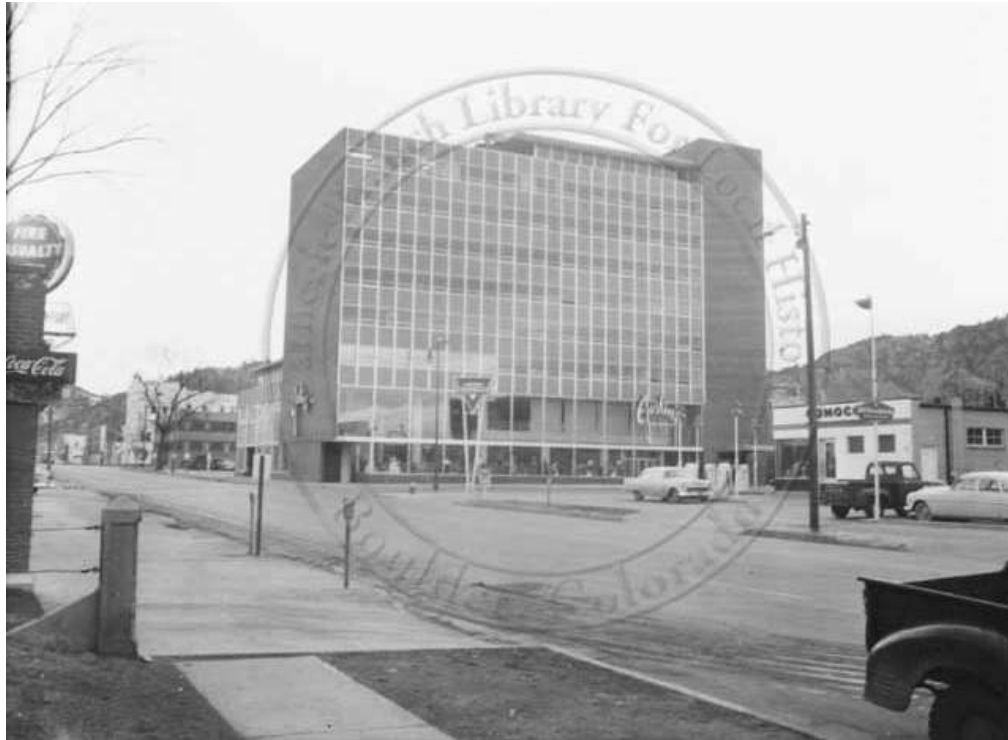
Figure 2. Colorado Building, 1919 14th St., 1957.

Designed by prominent Boulder architect James M. Hunter, the nine-story Colorado Building is one of downtown Boulder's most prominent visual landmarks. The building, completed in 1957, was originally planned as a "six-story, glass and native stone structure, which will be designed somewhat along the lines of United Nations headquarters (completed in 1952)."¹ The Daily Camera reported that the Colorado Insurance Building was the first private building project to exceed \$1,000,000 in the city of Boulder. The three lower floors were designed to hold a department store, Joslin's, described as the "first big store in Boulder." The building, measuring approximately 100 ft. in height, was erected before Boulder imposed a height restriction of 55 ft. in 1972.

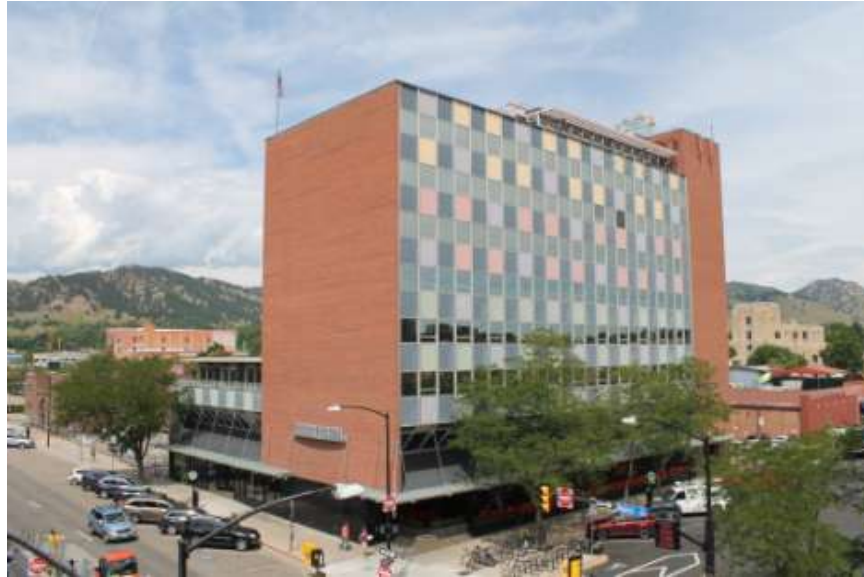
Figure 3. South and east facades, 1919 14th St., 2014.

The nine-story building features red brick walls that bookend a glass and aluminum curtain wall. The brick walls, located on the north and south elevations, are subtly textured with protruding horizontal brick bands, approximately located at each floor plate. Vertical tiles, measuring approximately 4" by 12", wrap the ground floor of the building.

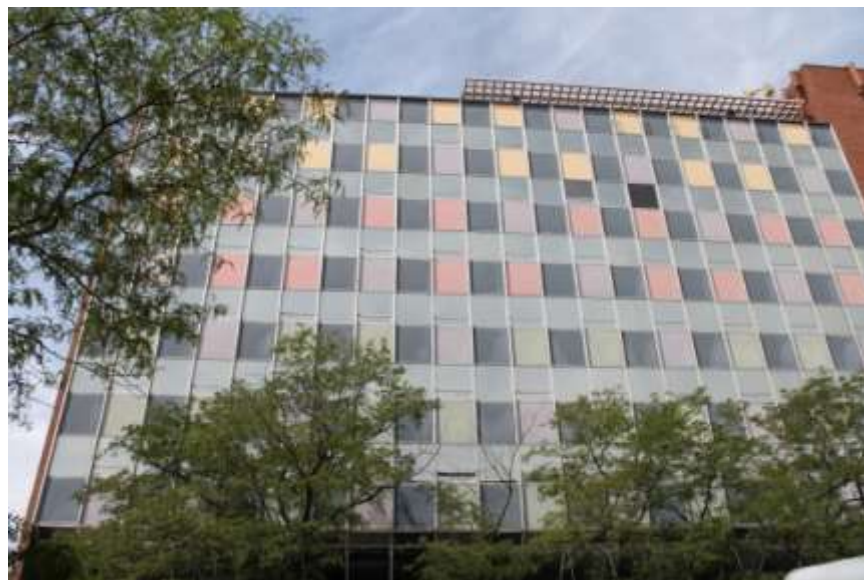
Figure 4. East Façade, 1919 14th St., 2014.

The east façade (facing 14th St.) features a large aluminum and glass curtain wall bordered by the masonry walls on the north and south. The curtain wall is composed of alternating horizontal bands of glass and painted panels.

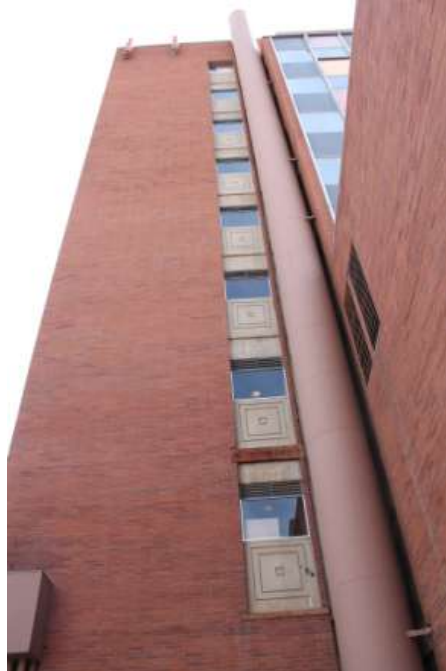
Figure 6. West Elevation, detail, 1919 14th St., 2014.

The west elevation of the office tower features a paneled glass curtain wall. The brick wall at the north end is recessed and features concrete panels at each level. The west elevation of the pavilion features regularly spaced sliding glass windows. The recessed third floor with the gridded sunshade extends approximately two-thirds of the elevation. A northernmost portion of the elevation is painted.

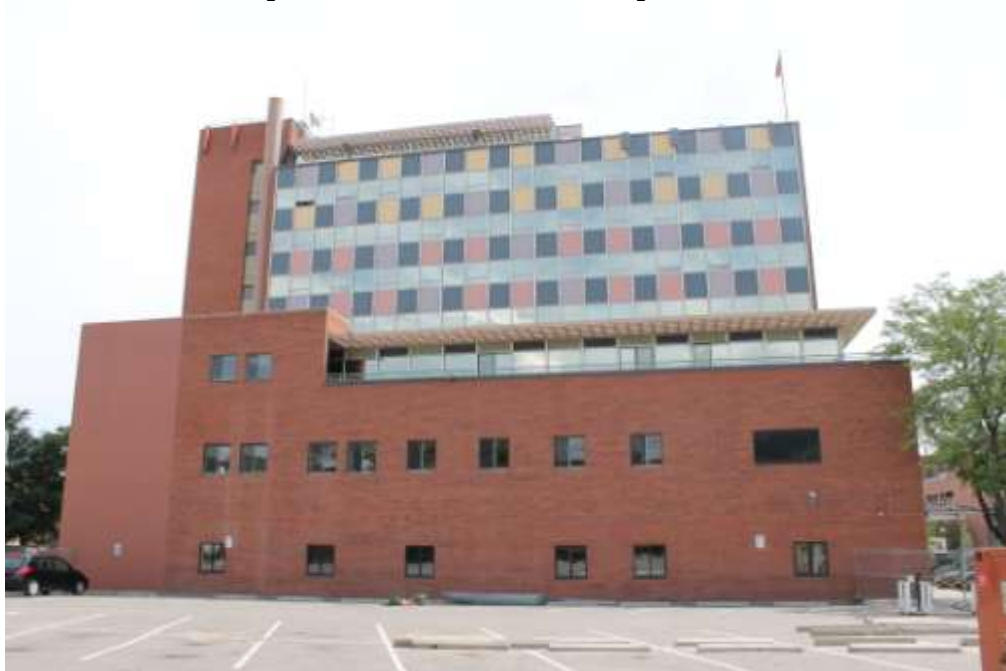
Figure 7. West Elevation, 1919 14th St., 2014.

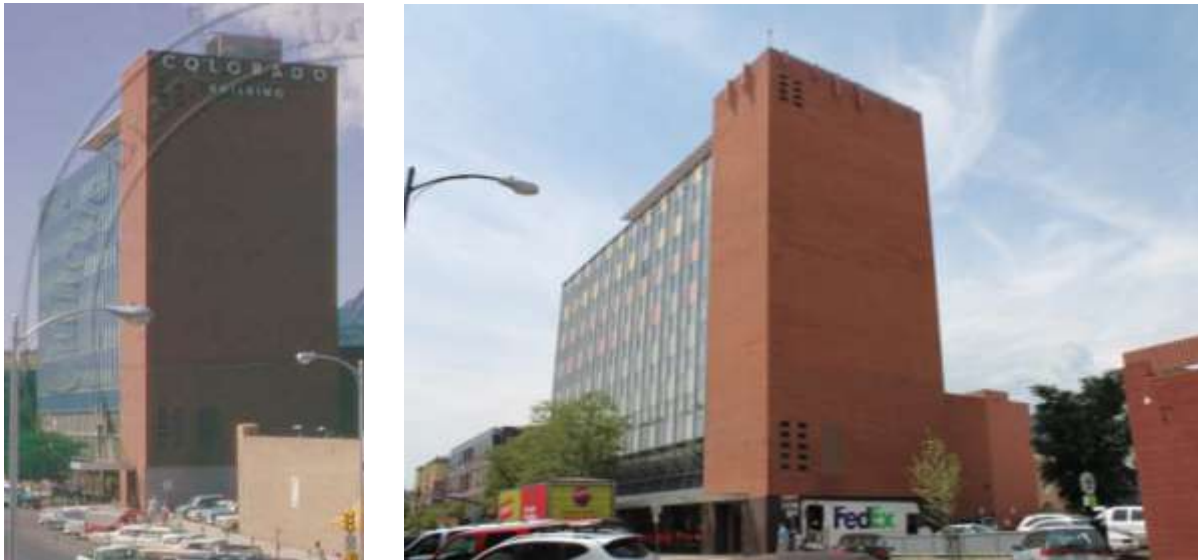
The north elevation is nearly identical in design to the south elevation. The wall is subtly textured with slightly protruding horizontal bands of brick, as seen on the southern elevation. A 1966 photo shows that the north elevation originally featured a “Colorado Building” sign near the top that was identical to the sign seen on the south elevation.

Figure 8. Northeast corner, 1919 14th St., 1972 (left) and 2014 (right).

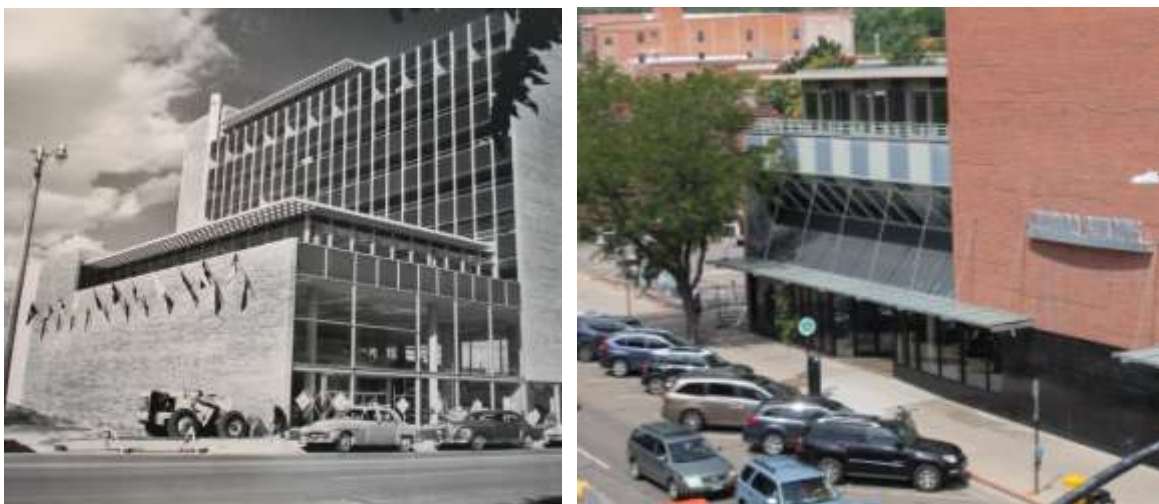
The building underwent a series of alterations in the 1980s, including reconfiguration of the façade of the west pavilion and replacement of the glazing system. A contemporary awning was added around 2008. The polychrome paint scheme was introduced in the 1980s. Further information is needed to determine the original color, which appears in historic photographs to be either dark gray or a blue-green color.

Figure 9. South Elevation, 1919 14th St., 1956 (left) and 2014 (right). The pavilion portion of the building was remodeled in the 1980s.

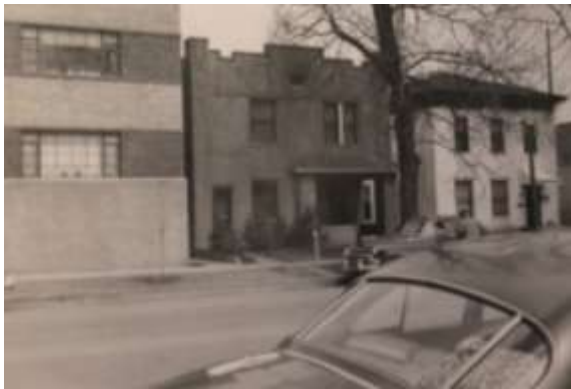
Figure 13. Tax Assessor Photo for 1313 Walnut Ave. (center) and 1321 Walnut Ave. (right) c. 1934.

A brick duplex was located directly east of the 1940s apartment building (1309-11 Walnut St.). The south façade featured a stepped parapet, decorative brickwork, and two entrances covered by hipped roof porches. The two-story brick house at 1313-15 Walnut St. featured a hipped roof, wide double-hung windows, and a gable roof porch over the Walnut St. entrance (visible in the c.1929 tax assessor photograph by removed by 1949). The property's brick accessory building (1922 ½ 13th St.) is still standing today.

The one-story, brick house located at 1321 Walnut St. featured a hipped roof with decorative brackets, paired double-hung windows and a front stoop. The wood-frame house at 1335 Walnut St. (stuccoed by 1950), featured a crisp gable roof with overhanging eaves and stone hoods above two-over-two double-hung windows. Little is known about the residents of these houses.

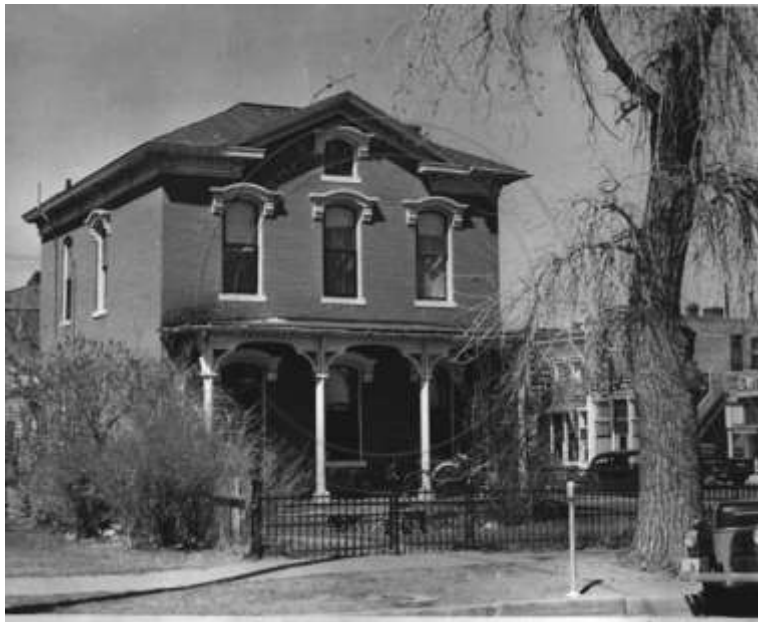
Figure 18. Bernard and Elizabeth Mallon House, 1341 Walnut St., c.1940.

The grandest house on the block was constructed in 1882 by Bernard and Elizabeth Mallon. Prominently located on the northwest corner of Walnut and 14th streets (1341 Walnut St.), the Italianate house featured a symmetrical façade with segmentally arched windows with hooded surrounds, a hipped roof with decorative brackets, a roof pediment and porch with decorative posts on the south elevation. A second porch was located on the east elevation. The building, with an ornate wrought-iron fence, was demolished in 1955 to make way for the Colorado Building.

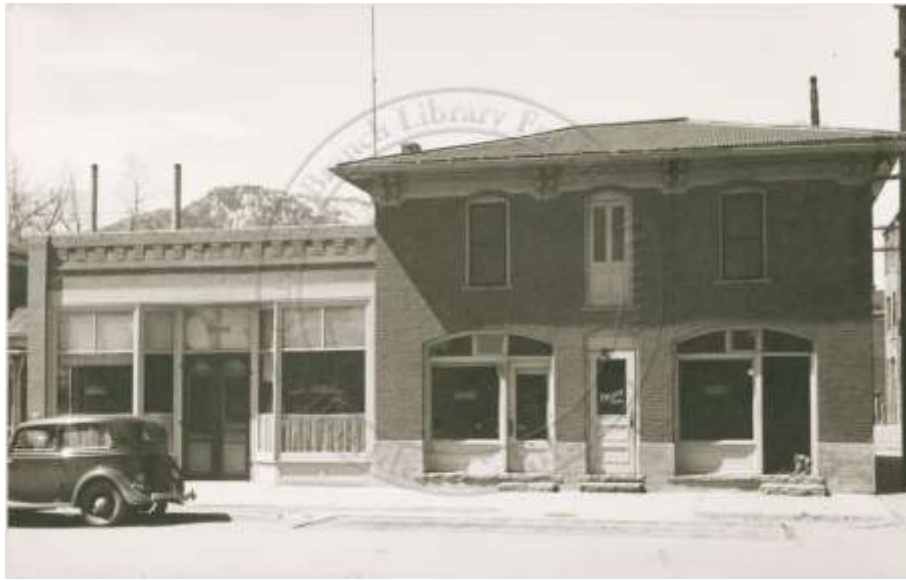
Figure 19. Photo of 1921 14th St., c. 1937.

City Hall was originally located at 1921 14th St. The two-story Italianate building originally served as the city's fire station. The tall, arched bays were enclosed when the building was converted to office use. The one-story, brick commercial building housed the sheriff's office and later the planning offices. The buildings were vacated when the Municipal Building, also designed by James Hunter, was constructed in 1951.

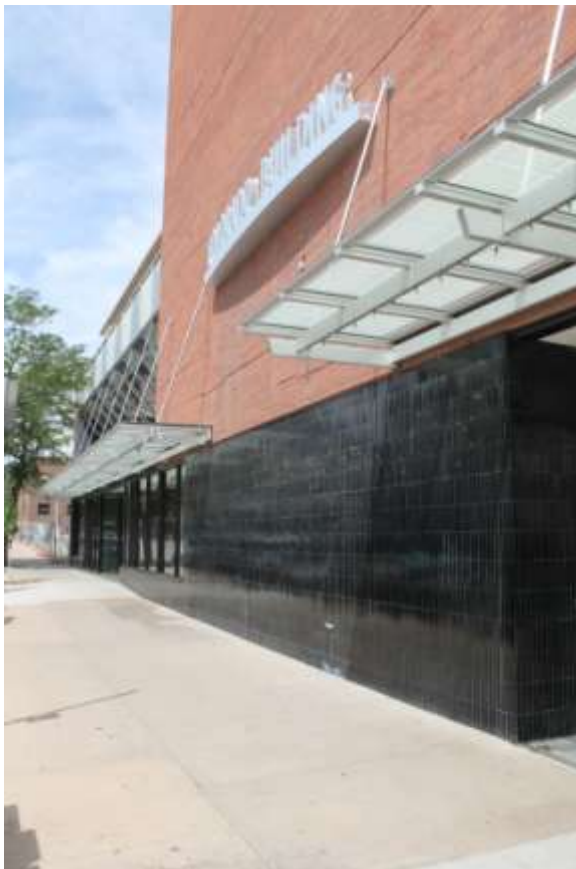
1919 14th St., close up of exterior ground level on south elevation, 2014.

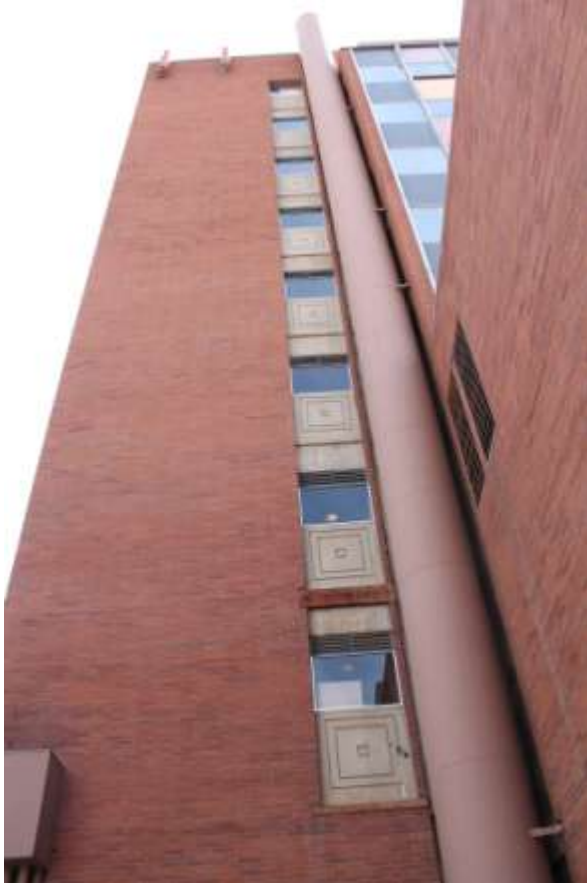
1919 14th St., close up of concrete detail at northwest corner, 2014.
